CCGA packages for space applications

Reza Ghaffarian *

Jet Propulsion Laboratory, California Institute of Technology, 4800 Oak Grove Drive, MS 125-152, Pasadena, CA 91099-8099, United States

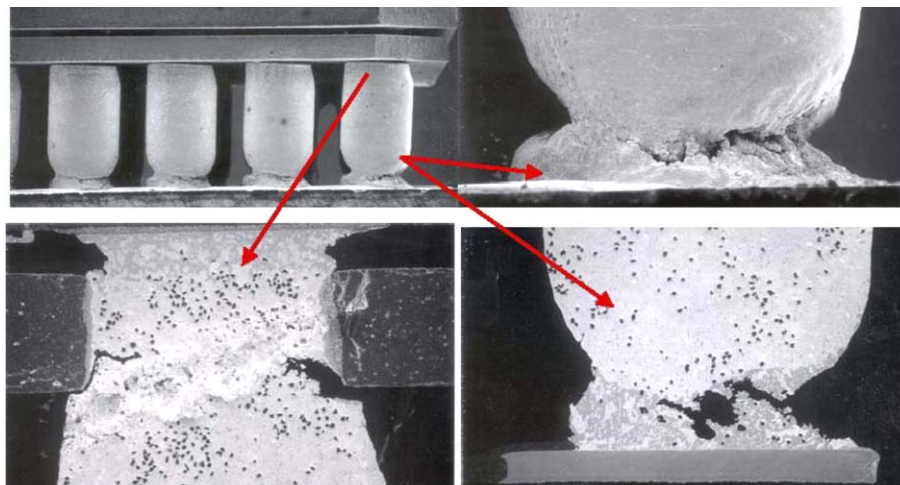
Fig. 2 shows SEM photomicrographs and cross-sections of the 560 I/Os CCGA assemblies after cracking due to thermal cycling. Fig. 3 shows the microstructure of another CCGA package assembled with Pb-free (Sn/Ag/Cu) solder [13]. For CCGA assemblies, the 3D optical microscopy and visual inspection are limited to inspection of the outer rows. Such inspection can be performed only when sufficient gaps are allowed between the assembled parts. Note that the assemblies show signs of damage/cracking after thermal cycling.

Fig. 2. SEM photomicrographs and cross-sections of CCGA 560 I/Os assembled with tin–lead solder after thermal cycling showing damage/cracks.

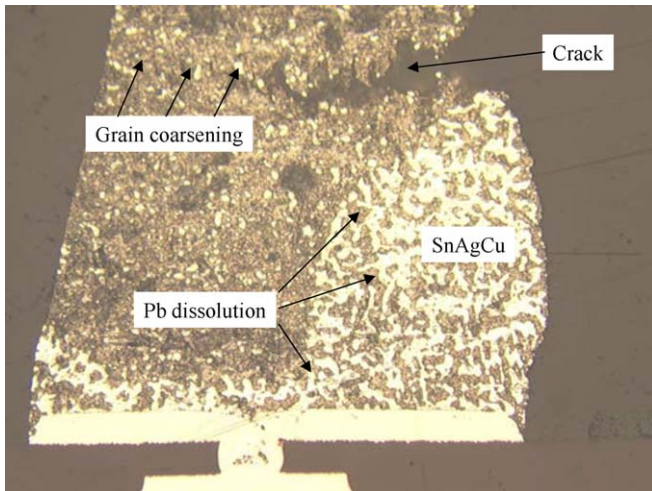
Fig. 3. 1657 I/Os CCGA high-lead solder column on a microvia pad PWB with Sn–Ag–Cu solder joints (courtesy of Dr. D. Shangguan/T. Castello).

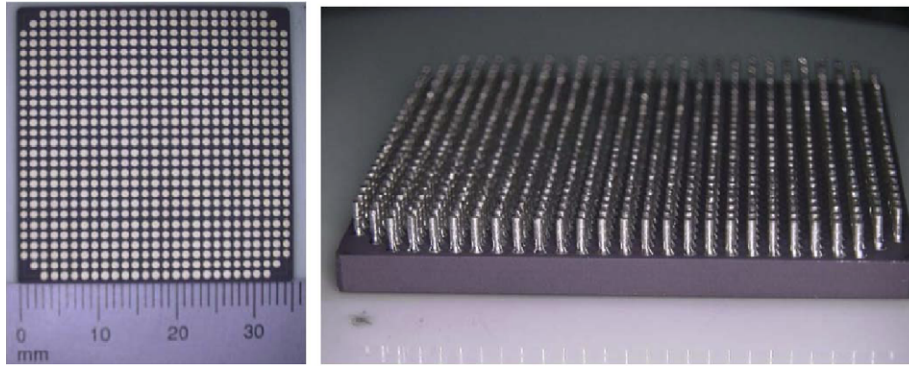
Fig. 4. Photomicrograph of a CCGA 717 I/O package showing its dimensions and its column feature having no corner columns for reliability improvement.

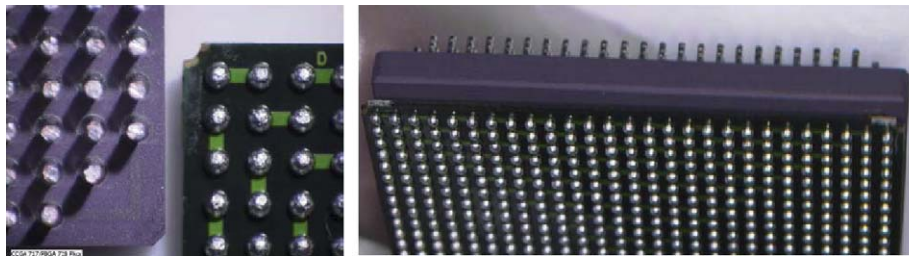
Fig. 5. Photomicrograph of a CCGA 717 I/O package contrasted with its plastic counterparts with its corner balls removed to assemble the PBGA package on the CCGA PWB pad design.

- Assembled CCGA 717 I/Os and 728 I/Os on one pad considered to be acceptable for the CCGA 717 I/Os. PBGA corner balls were removed in the PBGA 728 assembly to utilize the 717 I/O pad pattern (see Fig. 4).

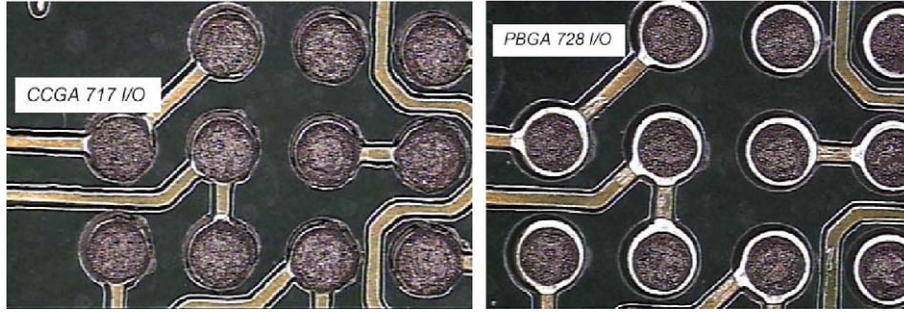
An example of laser measurement for the top left corner and solder paste distribution values is shown in Fig. 7. The specific tool provides automatic control for measurement and has an undesirable maximum level cut-off value feature, making it very difficult to expand the theoretical measurement by software to include the volume under the peak values. This limitation of software led on many occasion to wrong readings for often observed an abrupt paste print. Eventually, the paste print height had to be verified by using filler gages and the uniformity of print verified by inspection using an optical microscope. On the other hand, the 3D optical microscope could reveal the distribution covering for a larger area, but it lacked accuracy (see Fig. 8).

Fig. 8. Solder paste deposition for CCGA 717 and PBGA 728 using the pad design for CCGA 717 I/O—higher solder paste volume required for CCGA package assembly to achieve optimum reliability.

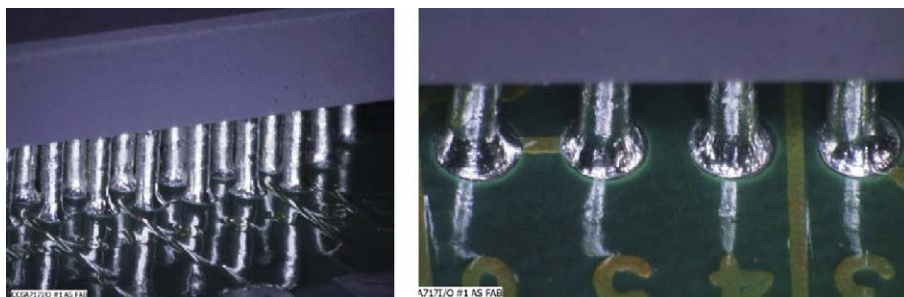
Fig. 9. Optical photomicrographs of a PBGA and a CCGA after assembly but prior to thermal cycling.

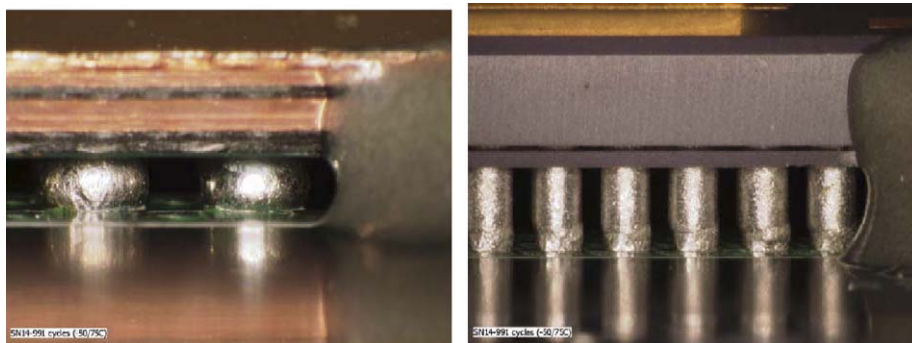
Fig. 10. Optical photomicrographs of PBGA (left) and CCGA built with a 10.5 mil thick stencil after 991 cycles Cycle A (−50/75 °C)—corner staking adhesives apparent at the two corners.

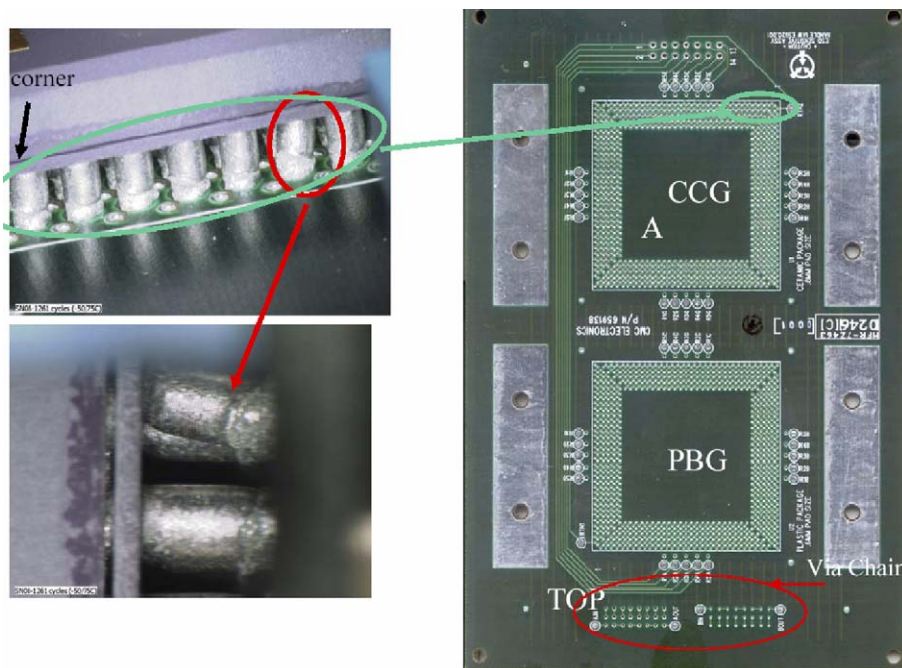
for inspection and failure verification. It is interesting to note that failure did not occur at the board site, a more common failure location; rather, it occurred at the package site. Hence, solder joint damage at the board interface may not always be used as a representative of damage progress. In addition, solder joint failure is not at the corner columns as generally expected to occur for ceramic area array package assemblies. Solder joint damage conditions for assemblies with low and high solder volume are shown in Fig. 12 showing significant damage at the board site for the low solder volume condition. Failures were in solder joints at the board site for the assembly with low solder volume as shown in Fig. 13 taken at 1459 thermal cycles. Note that the corner columns at the board site are tilted more toward the center of the package due to the higher CTE mismatch compared to the interface at the package site.

Fig. 11. Optical photomicrographs of CCGA built with a 10.5 mil thick stencil after 1138 cycles Cycle A (−50/75 °C)—cracking from the package site rather than the board site commonly occurring.

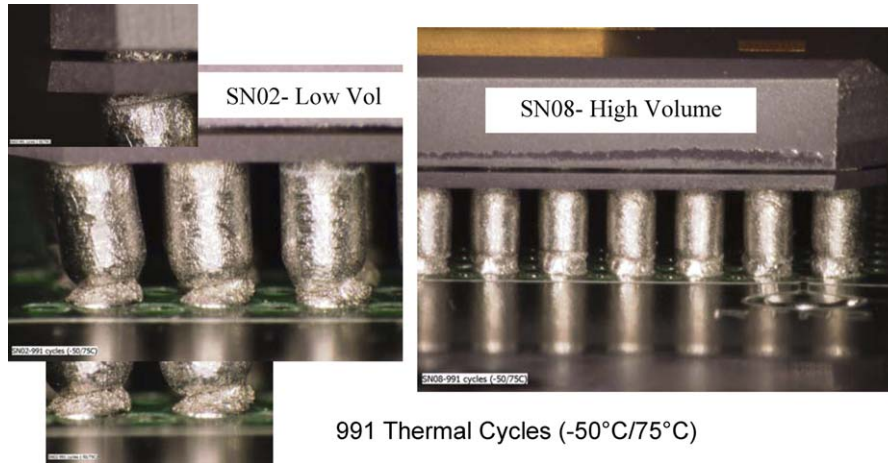
Fig. 12. Optical photomicrographs of CCGA assemblies built with an 8 mil (left) and 10.5 mil thick stencil after 991 cycles Cycle A (−50/75 °C).

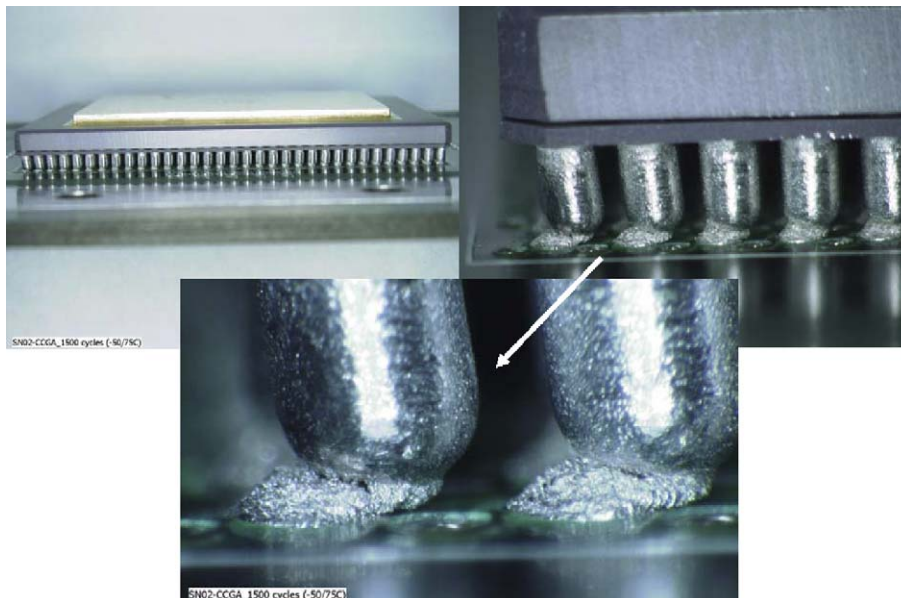
Fig. 13. Optical photomicrographs of CCGA built with an 8 mil thick stencil after 1459 cycles Cycle A (−50/75 °C)—cracks in solder joints at the board site and shift of the corner columns towards the package center.

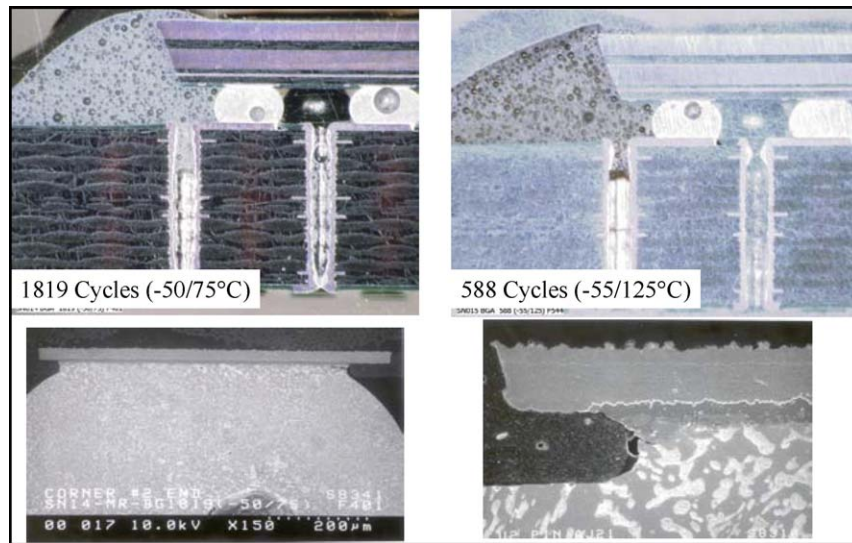
3.3.1.2. Corner-staking adhesive and failure mechanism change. Fig. 14 compares optical and SEM photomicrograph of a PBGA balls after exposure to 1819 cycles Cycle A (−50/75 °C) and another one subjected to 588 cycles in the range of −55/125 °C (Cycle C condition). Both assemblies had corner staking. No significant microstructural changes for the Cycle A condition was found, whereas a small microcrack was initiated in the solder joint at the package interface for the Cycle C condition (−55/125 °C). The latter photograph also clearly shows the grain growth due to exposure at elevated temperature. Similar optical photomicrographs for CCGA assemblies with corner staking after the same number of cycles and conditions: 1819 (−50/75 °C) and 588 (−55/125 °C) are shown in Fig. 15. Although both assemblies had identical build condition with identical corner staking materials, the failure

Fig. 14. SEM photomicrographs before and after cross-section for a PBGA package after 588 cycles (−55/125 °C).

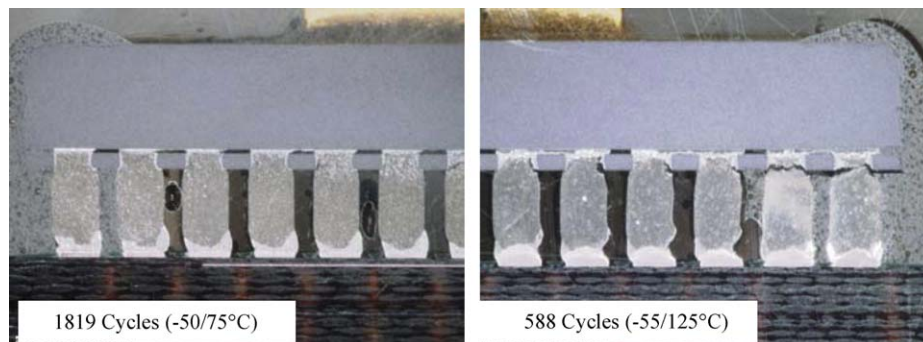
mechanisms were different and dependent on the temperature cycle range and the maximum temperature. One failed away from staking whereas the other (−55/125 °C) failed within the staking adhesive at the interposer solder interconnection interfaces.

Fig. 15. Photomicrographs of column failure at interposer with corner staking over two thermal cycle ranges.

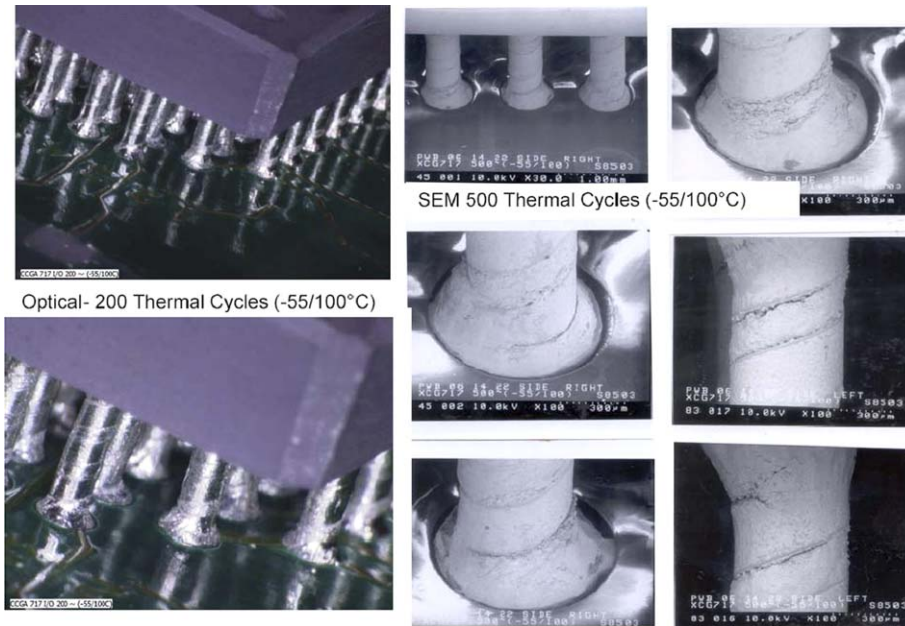
Fig. 16 shows optical and SEM photomicrographs of two CCGA 717 I/O assemblies at 200 and 500 thermal cycles Cycle B condition (−55/100 °C). The solder joints show signs of minor damage. Optical photomicrographs for a CCGA package assembly with and without corner-staking adhesive after 950 thermal cycles are shown in Fig. 17. At this high number of cycles, damage has not yet significantly increased. It is more severe for the one with

Fig. 16. Optical photomicrographs of CCGA a 717 I/O assembly (left) at 200 and SEM photomicrographs at 500 thermal cycles Cycle B (−55/100 °C)—signs of damage at 500 cycles is apparent.

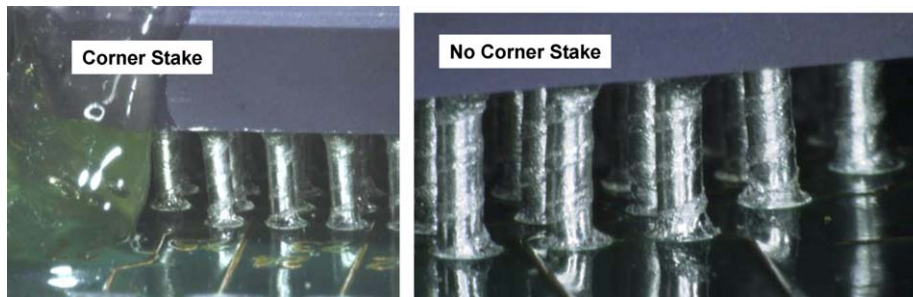
Fig. 17. Optical photomicrographs of two CCGA 717 I/O assemblies with (left) and without corner staking at 950 thermal cycles Cycle B (−55/100 °C) with a minor cracking at the corner column with corner staking.

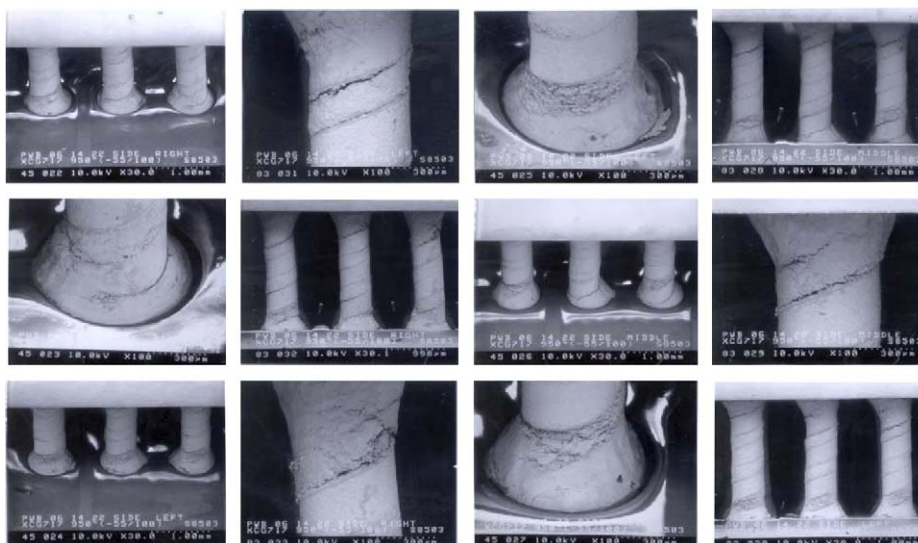
corner staking. SEM photomicrographs for different columns after 950 cycles are shown in Fig. 18. No failures were yet detected by electrical monitoring, but signs of damage at the board and package sites are apparent. Fig. 19 shows an optical photomicrograph of CCGA assemblies with and without corner staking and conformal coat after 340 extreme thermal cycles in the range of −120/85 °C (Cycle E). Both show signs of damage, but the damage is more pronounced for the one with corner staking and conformal coat. The columns appear to have been squeezed out at the copper wrap strips, possibly due to continuous exerted pressure by stiffened staking and conformal coating polymeric materials due to exposure to the very low temperature during thermal cycling. Generally, polymeric materials become more rigid as temperature decreases; therefore, they induce more stress due to CTE mismatches during thermal cycling.

Fig. 18. SEM photomicrographs of CCGA 717 I/O assembly at 950 thermal cycles (−55/100 °C) showing signs of microcracking.

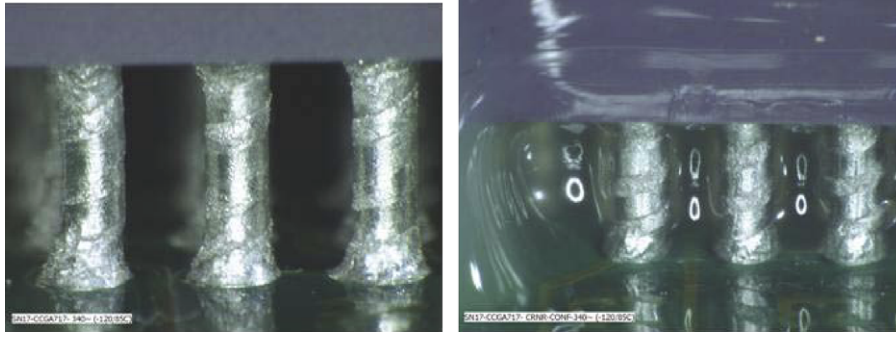
Fig. 19. Optical photomicrographs of CCGA 717 I/O assembly at 340 thermal cycles (−120/85 °C) showing signs of damage, left with no conformal coat and no corner staking and right with conformal coat and corner staking.

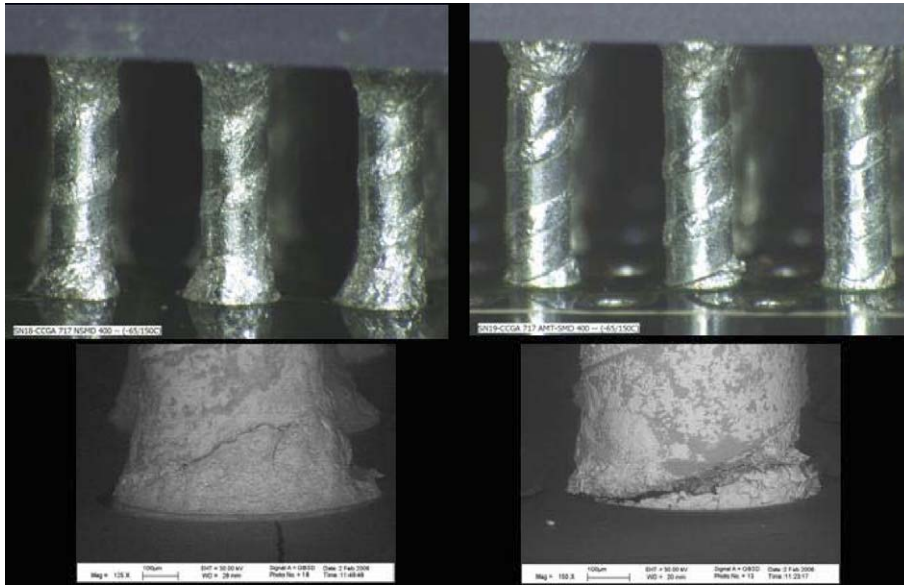
the range of −65 to 150 °C (Cycle D condition). The solder joints with the NSMD pad design show signs of severe damage and minor cracking, whereas those with the SMD pad designs are near failure with severe cracking at several column attachments. Even though such failures are well known for ball grid arrays, this is the first time that the effect of SMD pad design on promoting cracking has been seen for a column grid array assembly.

Fig. 20. Optical and SEM (bottom) photomicrographs of CCGA 717 I/O assembly at 400 thermal cycles (−65/150 °C) showing signs of cracking for NSMD pad design with good solder fillet (left) and failure for SMD (right) with lack of solder fillet.

- The CCGA 717 I/Os assembled onto PWBs with SMD pad design showed severe damage and cracking compare to NSMD design when subjected to −65 to 150 °C thermal cycling.

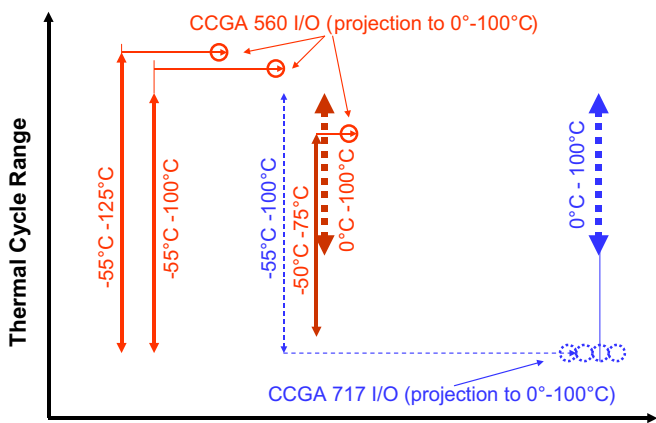
3.3.2.1. Projection of cycles to failure to 0–100 °C for CCGA 560 and 717 I/Os test results. Fig. 21 compares cycles to first failures (about 5% failure) for the CCGA 560 I/Os and CCGA 717 I/Os. The plots include the test results presented here and also data points from a comprehensive thermal cycle test performed in the range of 0–100 °C by another investigator [23]. These plots also include projection from our test results under various thermal conditions to 0/100 °C, a more common thermal cycle temperature range for commercial applications. A similar projection was made for CBGA failure data using Coffin–Manson relationship covering different thermal cycle regimes and

Fig. 21. Effect of temperature range on first failure for CCGA 560 I/Os and no failure yet (−55/100 °C) for CCGA 717 I/Os using a modified Coffin–Manson relationship.
